Update on the Old Inlet Breach and Great South Bay

Charles N. Flagg, Roger Flood and Robert Wilson
School of Marine and Atmospheric Sciences, Stony Brook University

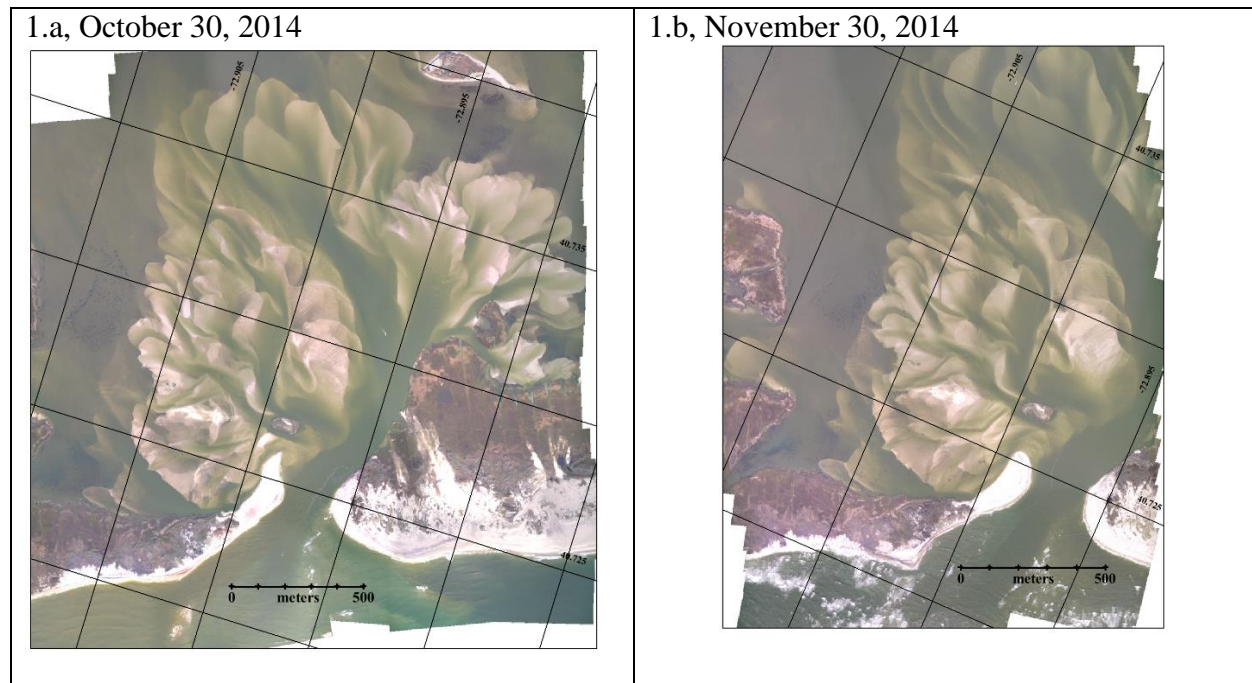
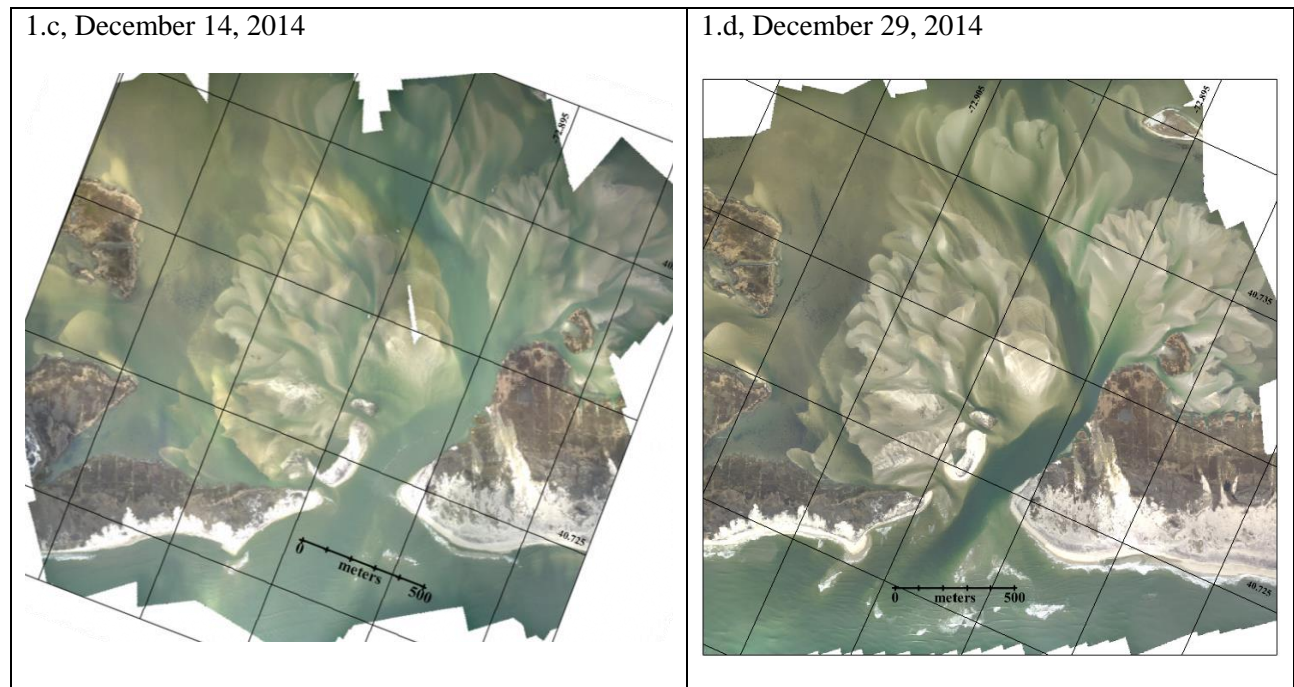
Over the past couple of months there have been some interesting developments in the breach with the further expansion and then bifurcation of the western spit, and changes to the western shoreline. By the end of November, the western spit which had begun to develop in September was more than 100 meters wide and extended about 300 meters along the main channel toward Pelican Island. In the early part of December, there were a couple of minor wind events, one of which on the 7th produced winds of around 30 kts from the northeast. This resulted in a break about 50 meters wide in the spit at the location of the old west channel as shown in the photo mosaic in Figure 1c. Compared to the mosaic from two weeks earlier, Figure 1b, the spit had also pushed another 100 meters to the north and the gap between the spit and Pelican Island had shrunk to less than 100 meters. Between the middle and the end of December, the west channel had expanded to about 100 meters while the gap between the spit island and Pelican Island was better defined and only 50 meters wide, Figure 1d. (Larger versions of these photo mosaics are available on the project website: <http://po.msac.sunysb.edu/GSB/>)

Another aspect of the breach development has been the change in the shape of the beach immediately to the west. Since earlier this summer there has been increased erosion over 600 to 700 meters of the beach and lately, the formation of a cusp and shoal off the southwestern corner of the breach. Comparing the series of photo mosaics over the past year, one can see that nearly 100 meters of beach has disappeared in this area since the beginning of 2014. This change may be associated with the rotation of the main channel through the breach. Last January, the channel was oriented nearly normal to the beach line but since June has had a more north-south axis. The shoals within the breach on either side of the channel still exist while the minimum width of the channel is roughly 150 meters as shown in Figure 1d.

The flight on December 29, Figure 1d, took place during low tide in the Bay and a remarkable number of flood delta shoals had risen above the water. An oblique photo from the northeast, Figure 2, shows the extent of these shoals located on both sides of the main channel extending from Old Inlet to the Smith Point Channel and all the way north to just short of John Boyle Island. While it was low tide at the time of this photo, it was not an extreme tidal event, see Figure 3 below. This suggests that while the flood delta has expanded considerably in all directions, it is not simply spreading out the existing sand reservoir but, as expected, accumulating more sand through the breach.

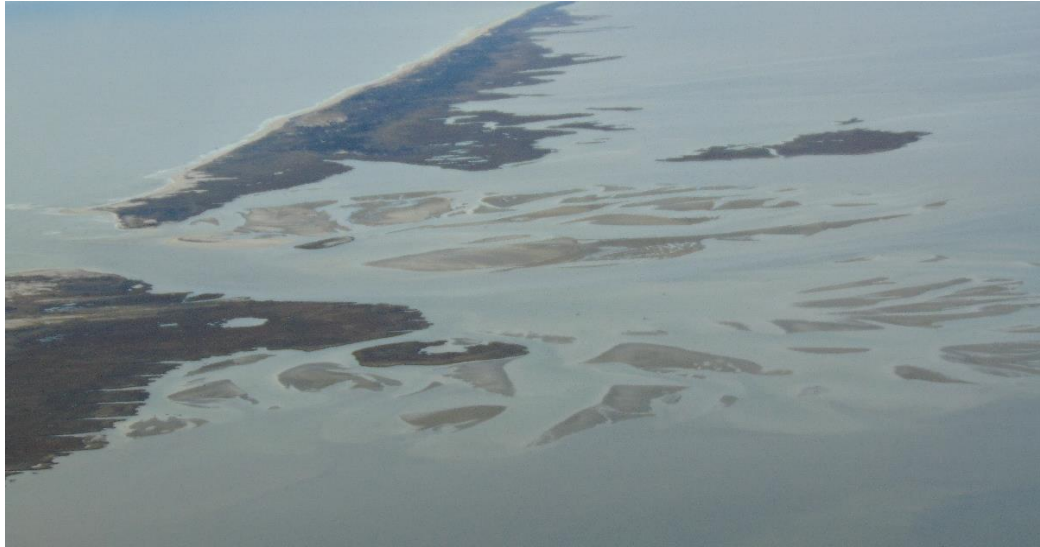
Figure 2, Oblique aerial photo from the northeast of the flood delta during low tide on December 29, 2014.

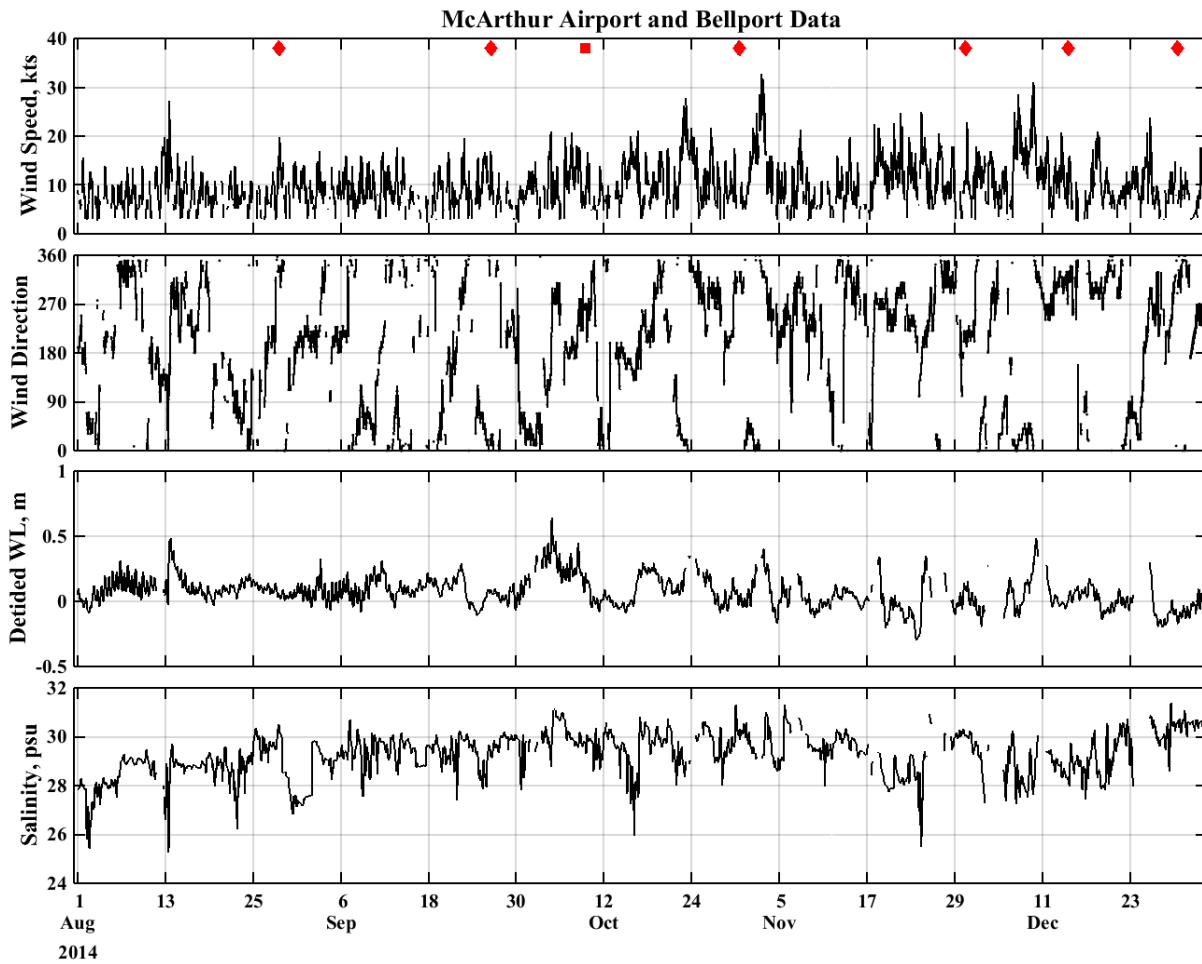
Figure 3, Time series plot of wind speed and direction from MacArthur Airport and detided water level and salinity from the Bellport SeaCat. The red diamonds along the top indicate times of aerial overflight while the red square indicates the time of the latest bathymetric survey of the breach.

To get a longer term view of the changes within the Great South Bay Figure 3 shows the wind record from MacArthur Airport plus the water level and salinity data from Bellport from mid-summer to the end of the year. (The GSB1 buoy wind sensor conked out in early December so the airport record is used instead.) The wind record shows that there were five events in the past five months with wind speeds greater than 25kts. Rather interesting is the fact that for all but one of these, December 7th, the winds came out of the northwest to north-northeast directions. That means that there was rather little ocean wave action and thus a relatively muted erosional response in the breach. The one exception on December 7th led, we think, to the redevelopment of the west channel. Comparing the water level data with the wind record shows that most of the highs and lows were associated with along Bay winds. Thus there was a period of moderate winds from the west in early October which raised mean sea level at Bellport by 0.25 to 0.5 meters for several days. Salinity jumped up by ~1 psu as that event tapered off which suggests that water was brought in through the breach as the waters receded back to the west. The wind events of August 13th, November 3rd, December 10th and December 26th had similar water level responses, although not necessarily accompanied by similar salinity changes. Salinities at Bellport for most of this period averaged around 30 psu without any noticeable long term changes. The salinity increase through August appears to reflect the recovery of the Bay to the large rain events in July which had pretty well flushed out of the system by September.
